**Flood Control Project Maintenance  
Levee Inspections**

**Fall 2014 Levee Maintenance Deficiency Summary Report**

**Reclamation District No. 1660 Tisdale**

**Levee Inspection Report By Mile - Fall 2014**

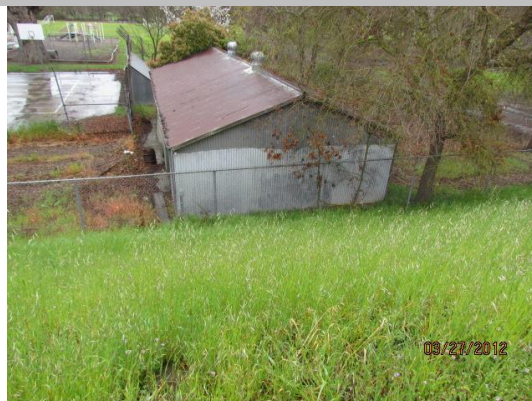
Photo 1 of 1 : FA\_2014\_RD1660\_8\_12\_20141013\_00006.jpg

LM Start	0.05	Rating **	M	Issue No.	12
LM End	0.05	Issue Type +	En	Location *	LS
Category	Earthen Levee			GPS Latitude/Longitude	
				Start	End
Item	Encroachments			39.062643 °	39.062643 °
				-121.837857 °	-121.837857 °
DWR ID	DWR_RD1660_01_s_2012_12				
Action/Comments					
Building

View of the building and fence at the landside toe.

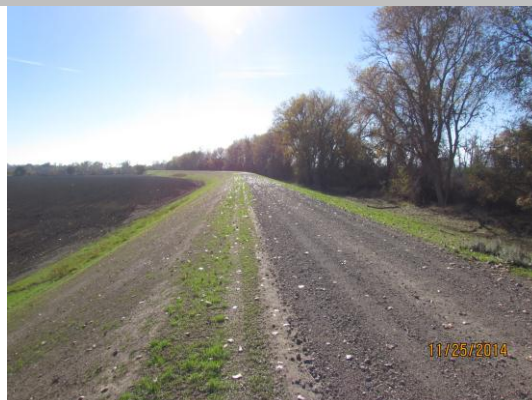
Photo 1 of 1 : FA\_2014\_RD1660\_8\_18\_20141126\_00010.jpg

View of the controlled vegetation on both slopes.

LM Start	0.45	Rating **	A	Issue No.	18
LM End	0.45	Issue Type +	Ma	Location *	LS
Category	Earthen Levee			GPS Latitude/Longitude	
				Start	End
Item	Vegetation			39.057015 °	39.057015 °
				-121.838768 °	-121.838768 °
DWR ID	DWR_RD1660_01_f_2014_18				
Action/Comments					
Control annual grass and weeds on the levee slopes and easements.

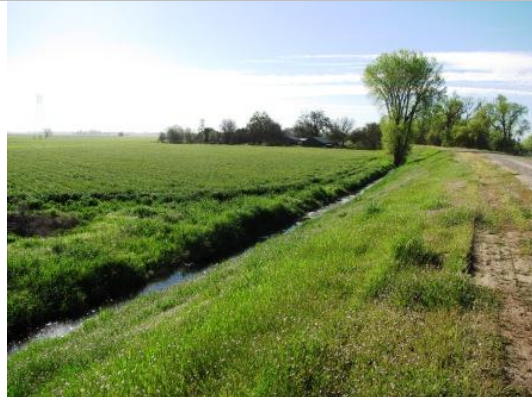
Photo 1 of 1 : FA\_2014\_RD1660\_8\_9\_20141013\_00004.jpg

LM Start	1.12	Rating **	M	Issue No.	9
LM End	1.43	Issue Type +	En	Location *	LS
Category	Earthen Levee			GPS Latitude/Longitude	
				Start	End
Item	Encroachments			39.047610 °	39.043622 °
				-121.838802 °	-121.836445 °
DWR ID	DWR_RD1660_01_s_2012_9				
Action/Comments					
Ditch

View of the ag ditch along the L/S toe.

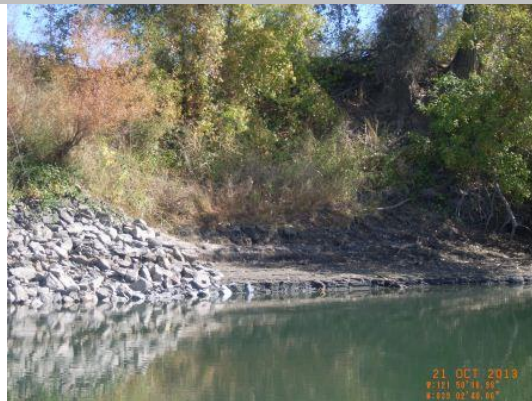
Photo 1 of 1 : FA\_2014\_RD1660\_8\_8\_20141013\_00003.jpg

LM Start	1.27	Rating **	M	Issue No.	8
LM End	1.37	Issue Type +	Ma	Location *	WS
Category	Supplemental			GPS Latitude/Longitude	
				Start	End
Item	USACE Erosion Survey			39.044361 °	39.043916 °
				-121.837654 °	-121.837305 °
DWR ID	DWR_RD1660_01_f_2014_8				
Action/Comments					
Inspector Comments: 2009 - Erosion on levee toe where an old cobble site is failing. 2011 - Some new minor erosion. 2012 - Site extended downstream, bank is being impacted from the weight of the trees. 2013: Minor new erosion at the toe. [2013 Site ID: SAC_120-6_L]

USACE 2013 Photo #1

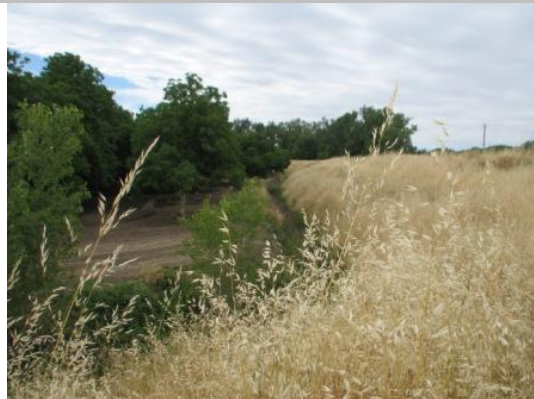
Photo 1 of 1 : FA\_2014\_RD1660\_8\_1\_20141013\_00001.jpg

LM Start	2.04	Rating **	M	Issue No.	1
LM End	2.38	Issue Type +	En	Location *	LS
Category	Earthen Levee			GPS Latitude/Longitude	
				Start	End
Item	Encroachments			39.037640 °	39.034416 °
				-121.828421 °	-121.825698 °
DWR ID	DWR_RD1660_01_s_2012_1				
Action/Comments					
Ditch

View of the large ditch along the landside toe.

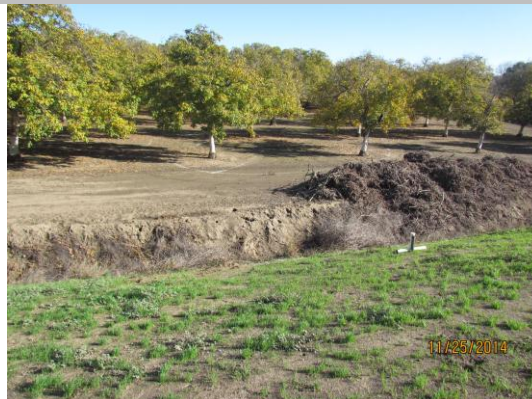
Photo 1 of 1 : FA\_2014\_RD1660\_8\_19\_20141126\_00011.jpg

View of the rodent holes and bait station.

LM Start	2.19	Rating **	A/W	Issue No.	19
LM End	2.19	Issue Type +	Ma	Location *	LS
Category	Earthen Levee			GPS Latitude/Longitude	
				Start	End
Item	Animal Control			39.035420 °	39.035420 °
				-121.828530 °	-121.828530 °
DWR ID	DWR_RD1660_01_f_2014_19				
Action/Comments					
No rodents visible, but rodent burrows visible; need to backfill and compact or grout burrows.

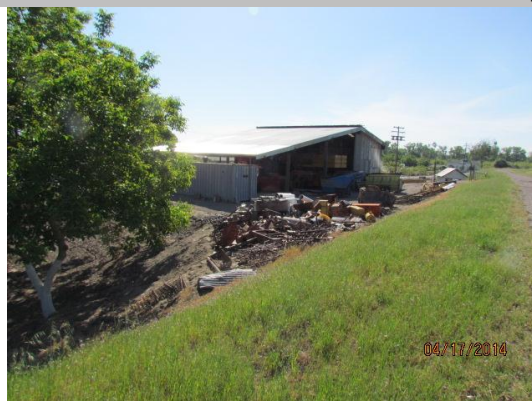
Photo 1 of 1 : FA\_2014\_RD1660\_8\_3\_20141013\_00002.jpg

LM Start	2.63	Rating **	M	Issue No.	3
LM End	2.63	Issue Type +	Ma	Location *	LS
Category	Earthen Levee			GPS Latitude/Longitude	
				Start	End
Item	Encroachments			39.031405 °	39.031405 °
				-121.823403 °	-121.823403 °
DWR ID	DWR_RD1660_01_s_2012_3				
Action/Comments					
Equipment

View of equipment along the landside slope.

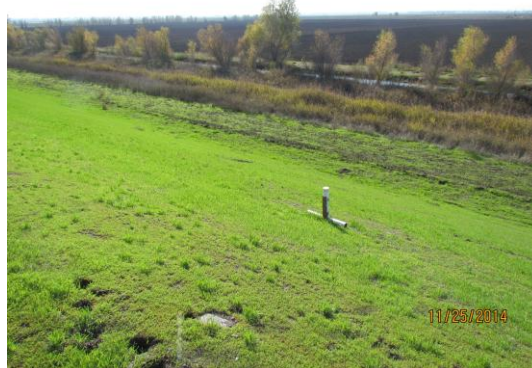
Photo 1 of 1 : FA\_2014\_RD1660\_9\_4\_20141126\_00002.jpg

View of the rodent holes and bait station along the landside slope.

LM Start	2.59	Rating **	A/W	Issue No.	4
LM End	2.59	Issue Type +	Ma	Location *	LS
Category	Earthen Levee			GPS Latitude/Longitude	
				Start	End
Item	Animal Control			39.068627 °	39.068627 °
				-121.758247 °	-121.758247 °
DWR ID	DWR_RD1660_02_f_2014_4				
Action/Comments					
No rodents visible, but rodent burrows visible; need to backfill and compact or grout burrows.

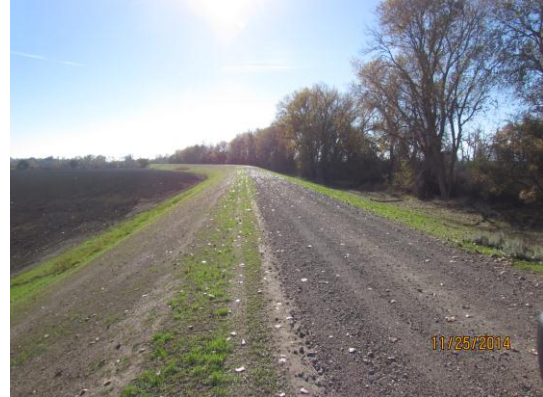
Photo 1 of 1 : FA\_2014\_RD1660\_9\_5\_20141126\_00004.jpg

View of the controlled vegetation on both slopes.

LM Start	6.05	Rating **	A	Issue No.	5
LM End	6.05	Issue Type +	Ma	Location *	LS
Category	Earthen Levee			GPS Latitude/Longitude	
				Start	End
Item	Vegetation			39.111395 °	39.111395 °
				-121.787905 °	-121.787905 °
DWR ID	DWR_RD1660_02_f_2014_5				
Action/Comments					
Control annual grass and weeds on the levee slopes and easements.
